Hawaiian Electric Company, Inc.'s
Report on the October 15-16, 2006 Outage

December 28, 2006

Investigation of 2006 Oahu Island-Wide Power Outage
PUC Docket Number 2006-0431

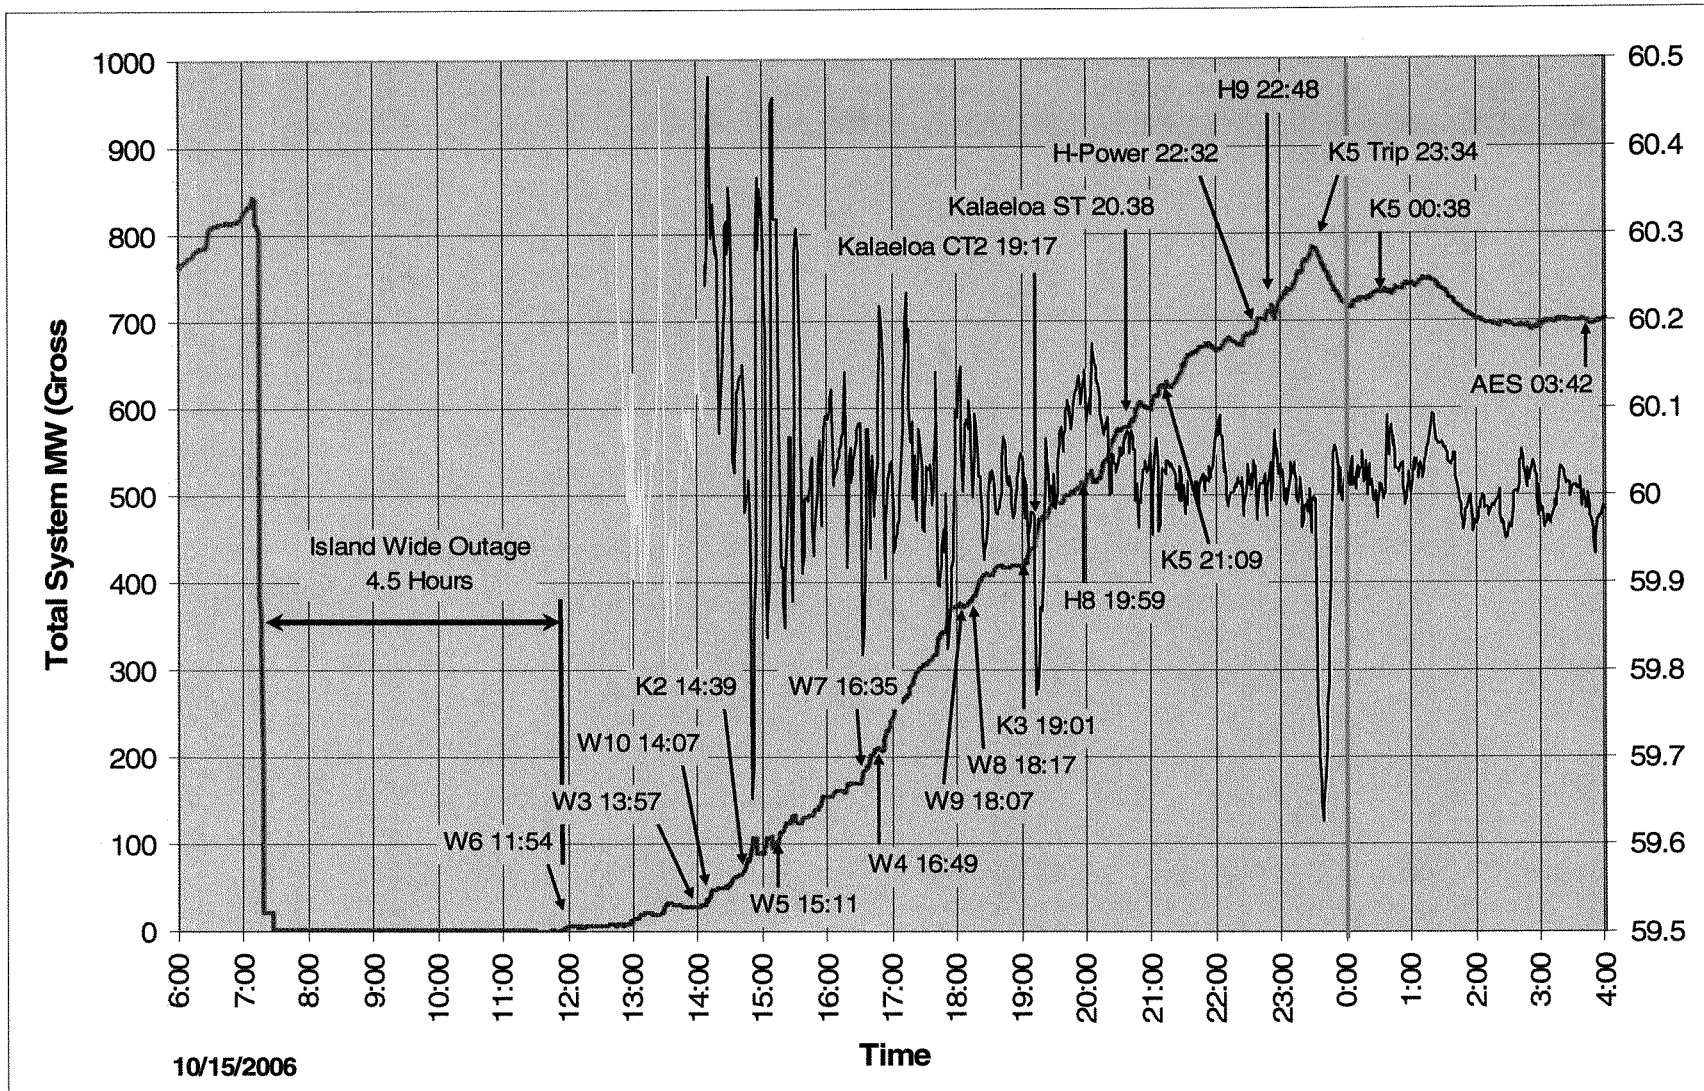
Figure 4: Generation Restoration Megawatts and Frequency versus Time

Based on a review of event historical frequency and voltage data, there were severe system instabilities during the first few hours of the system restoration. Figure 4 shows the frequency swings and Figure 5 shows the voltage swings that occurred with line and load additions over the course of several hours during re-energization of the grid. The swings in voltage and frequency observed by the COs and the LDs obviously raised concerns. If the fluctuations in voltage and frequency had been allowed to worsen, they could have resulted in manual or automatic trips of the units that were on line, resulting in black start from square one. Understanding and anticipating the system volatility during start-up, HECO operated in an orderly and methodical manner to add load to the system so that there was adequate opportunity to stabilize the operation of the generating units, and stabilize frequency and voltage on the grid.

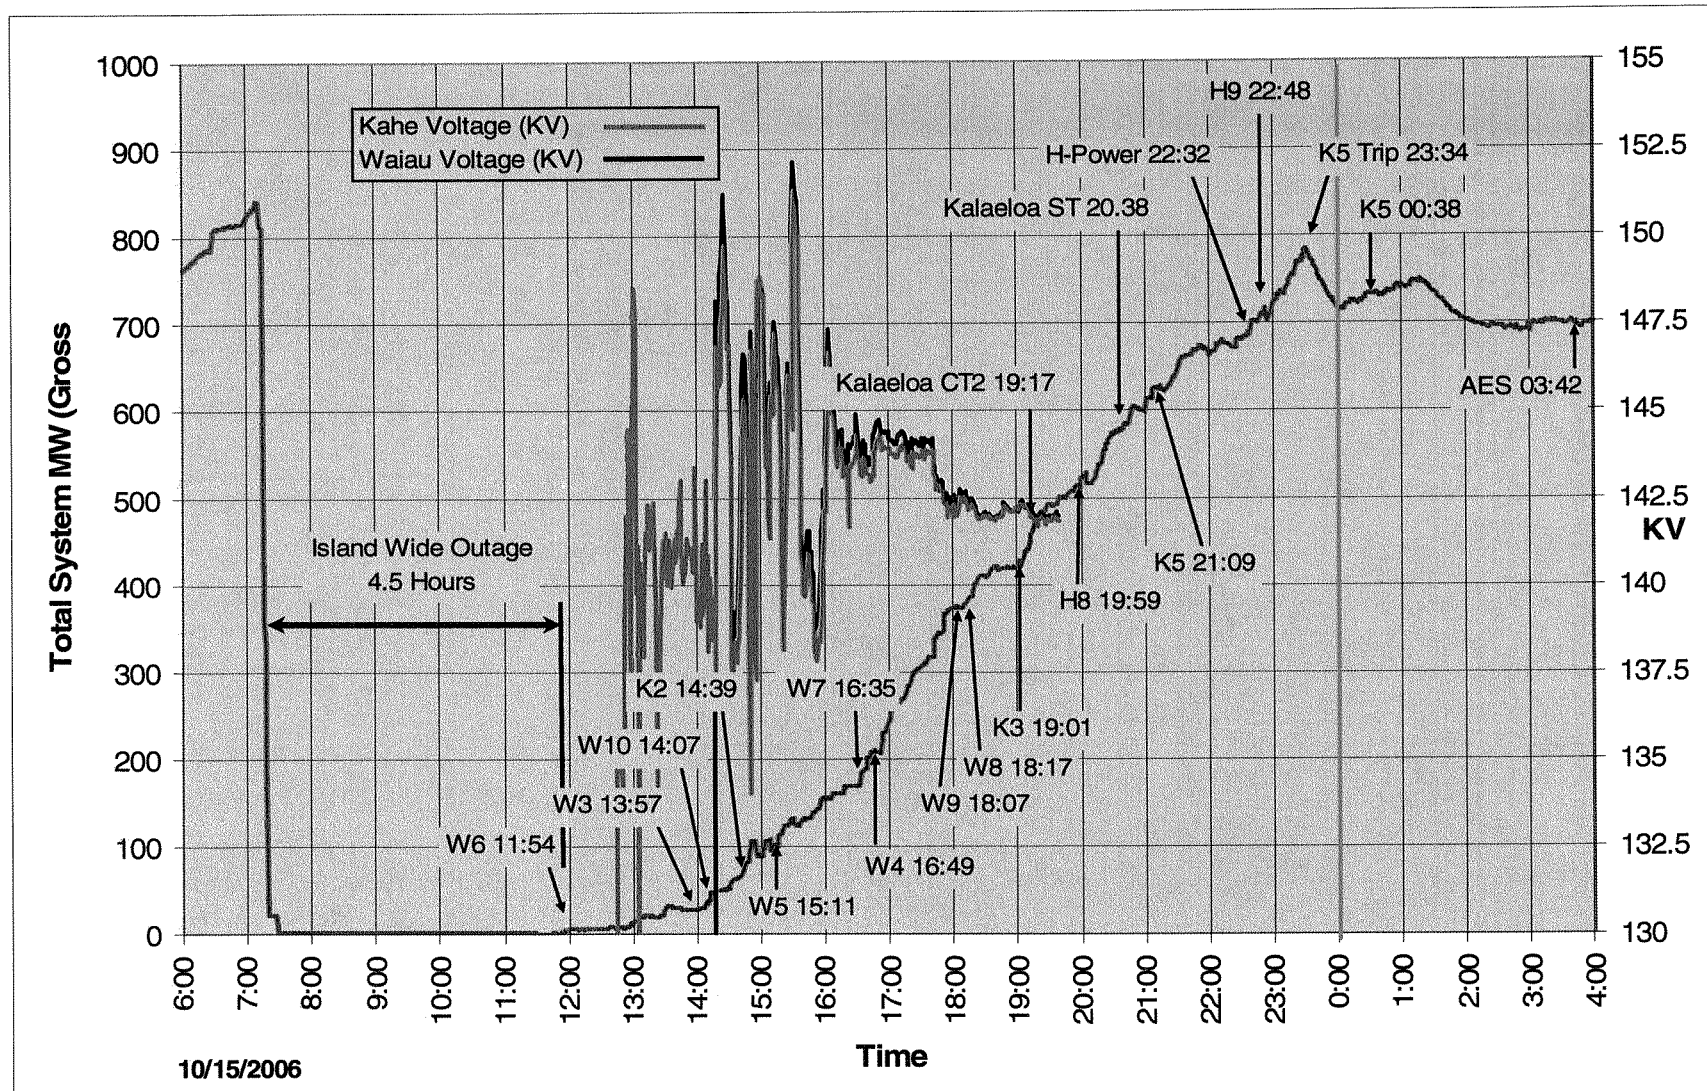
Figure 5: Generation Restoration Megawatts and Bus Voltage versus Time

The data reviewed shows that while the 138 kV transmission grid was being energized, extremely high voltages were encountered. These high voltage conditions could have been the result of a) the capacitance created on the lines because of the lightly loaded system, b) the W6 CO trying to control the MW output of the unit and the voltage on the system, or c) a combination of both. In addition to concern over HECO's own equipment, the LDs had concern for the impact of this high voltage on customers' equipment. When a high voltage situation arose, quick action was taken on the part of the LD to bring the voltage within operating range. In some cases the transmission line was taken back out of service by using the EMS to remotely open the circuit breakers in order to prevent damage to the system. In other cases, the LDs worked with the PTM to add loads to the system such that the inductive loads offset line capacitance to lower voltages on the transmission system.
